GM Gen. 2 6T70, 6T75, 6T80

sonnax®

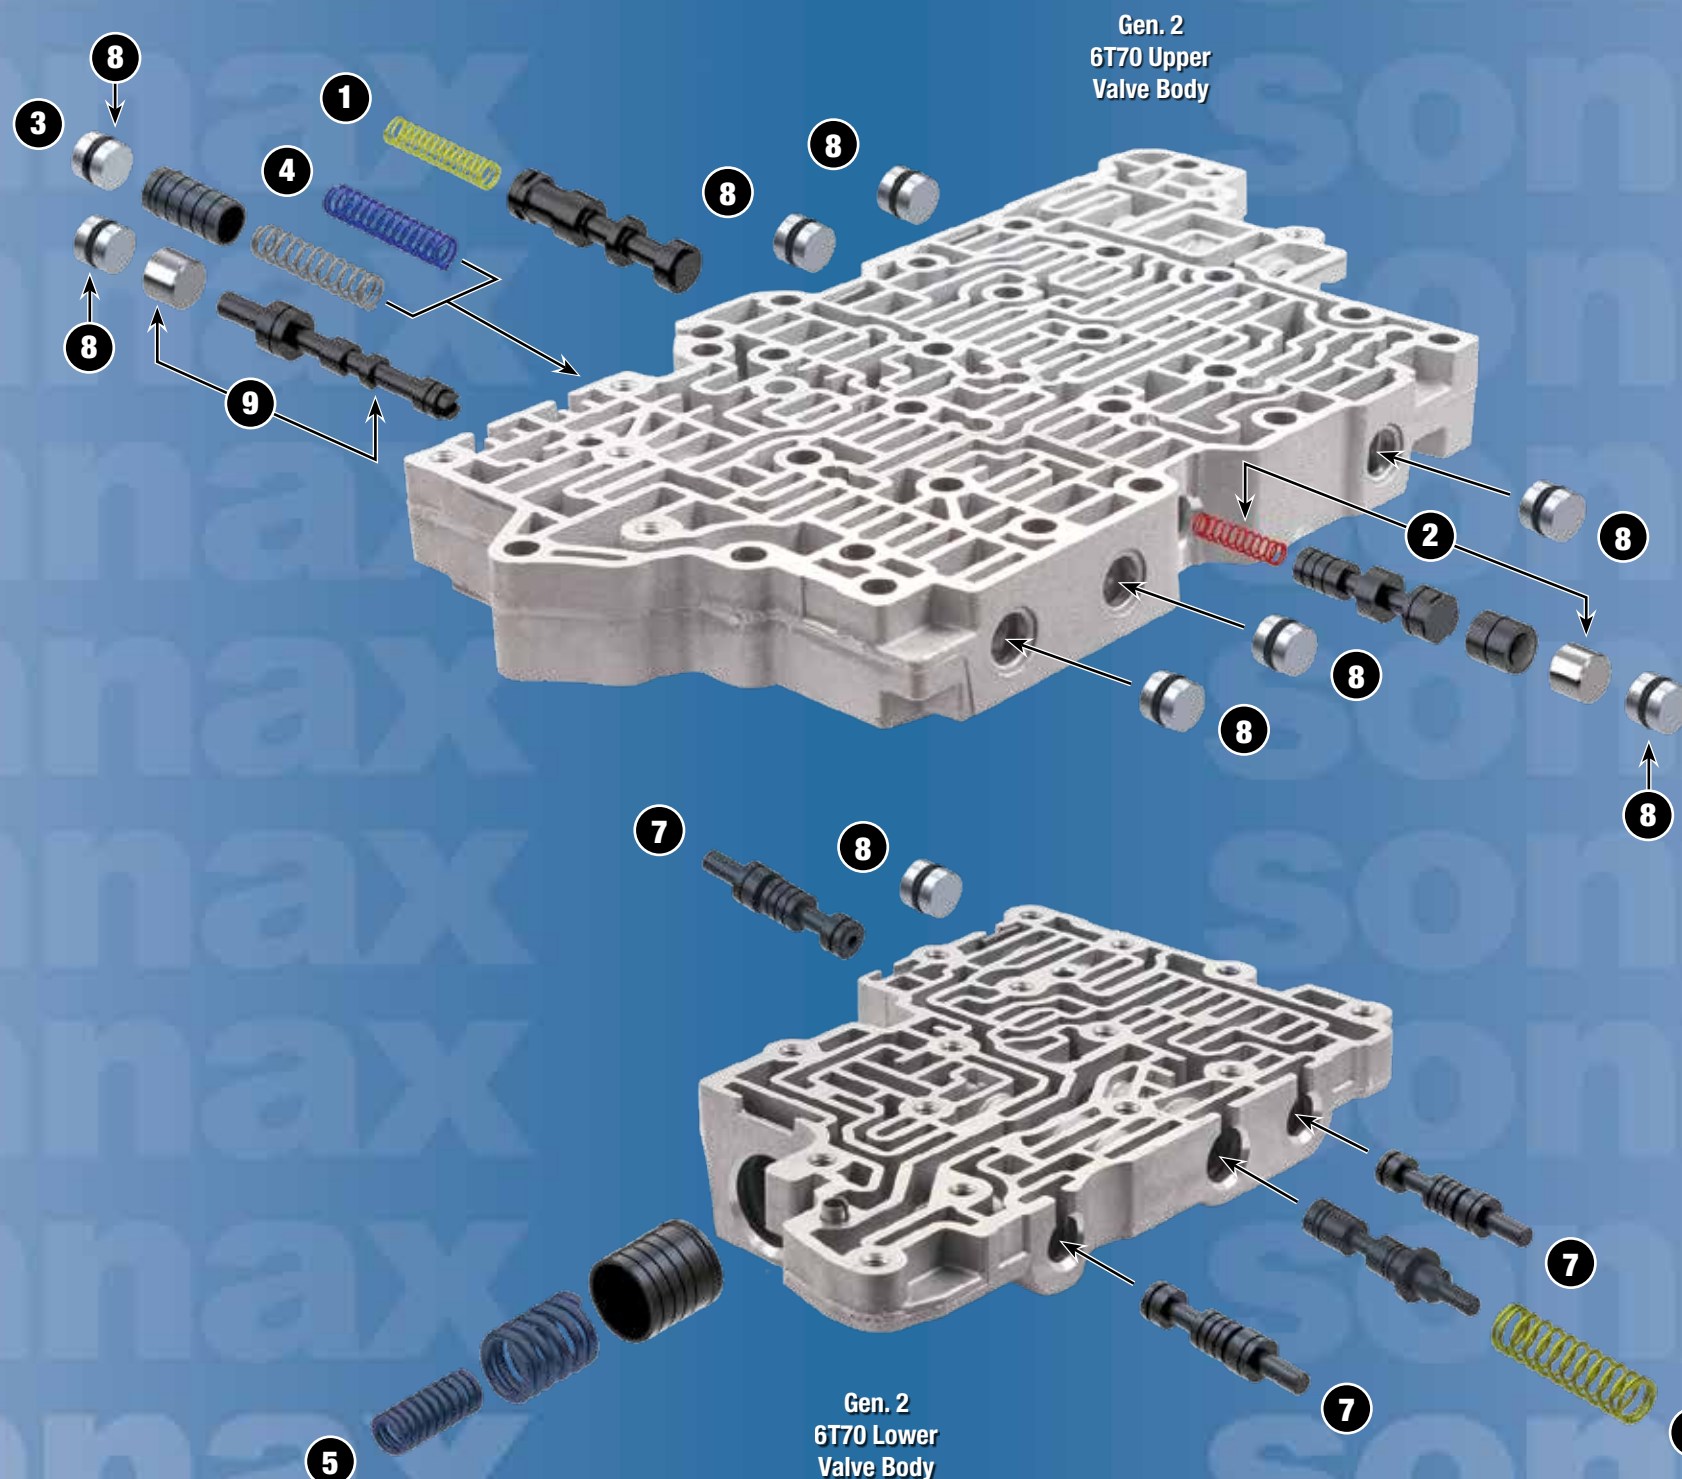
1 124740-14K Oversized TCC Control Valve Kit

Helps cure:

- Excess TCC slip • Low cooler flow
- Overheating • TCC apply & release concerns

2 124740-24K Oversized TCC Regulator Valve Kit

- Code P0741 • Code 742
- Harsh TCC apply • TCC slip

3 124740-03K Isolator Valve Kit

- Low line pressure • No line rise
- Line pressure instability • Burnt clutches

5 124740-57K 4-5-6 Accumulator Piston Kit

- 3-4 Flare • Ratio codes
- 4-5-6 Clutched Burned • Slipping gears

6 124740-48K Oversized AFL Valve Kit

- Solenoid performance codes
- Wrong gear starts • Clutch failure

7 124740-56 Oversized Clutch Boost Valve

Fits Any of 3 Locations

- Shift quality is not load sensitive
- Harsh shifts • Slips & flares

8 124740-02K O-Ringed End Plug Kit

- Pressure loss • Shift concerns
- Burnt clutches • TCC apply concerns

9 124740-60K Oversized Pressure Regulator Valve Kit

- Erratic line pressure • Poor shift quality
- Burnt Clutches • Low converter & lube flow
